NACA RM E52D10

INVESTIGATION OF ENGINE PERFORMANCE AND HIGH-TEMPERATURE  
 PROPERTIES OF PRECISION-CAST TURBINE BLADES  
 OF HIGH-CARBON STELLITE 21 AND  
 CONTROLLED-GRAIN-SIZE STELLITE 21

By Charles Yaker, Floyd B. Garrett, and Paul F. Sikora

Lewis Flight Propulsion Laboratory

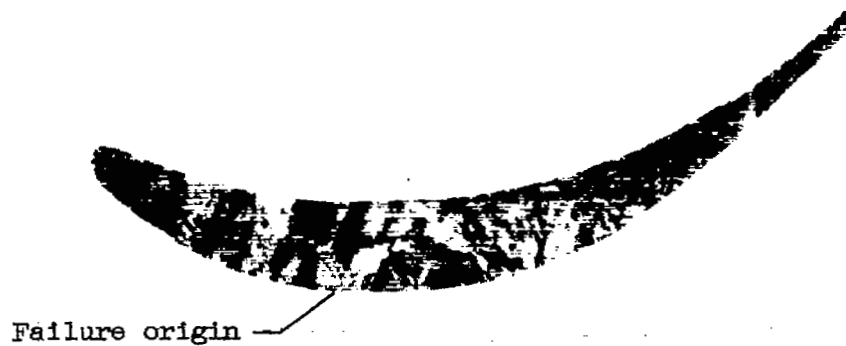
(a) Stress rupture.

Figure 9. - Types of blade failure.

(1) In figure 9(a) are shown failures in which the origin of the fracture is characterized by an irregular granular surface showing no evidence of fatigue-type failure. The fracture follows an intercrystalline path and small intercrystalline cracks are present in the area just below the failure zone. Because of the similarity of such failures to those encountered in laboratory stress-rupture tests, these failures were classed as the stress-rupture type.

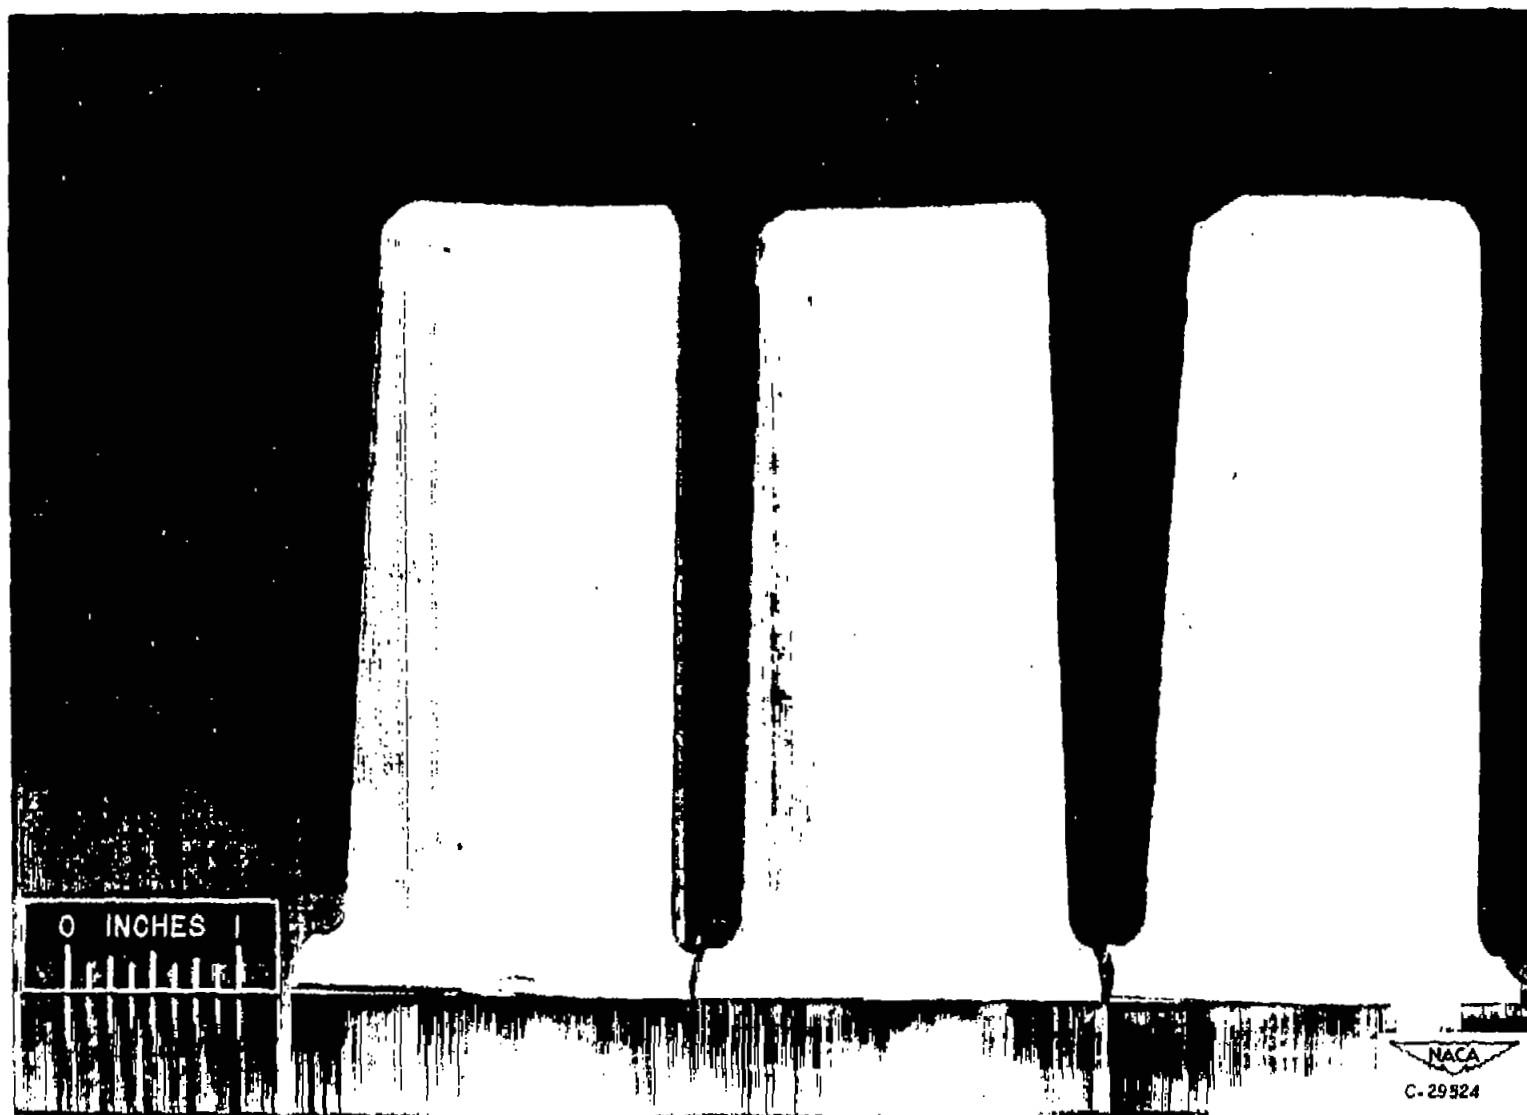
Figure 11. - Controlled grain-size blades macroetched to reveal grain structure.

The results of the grain-size measurements of the blades are listed in table V. Figure 11 presents a qualitative comparison of the three different grain sizes in the controlled-grain-size blades.
